## ROOF PROPOSAL

## KACHINA MEDICAL PLAZA B

2451 S Avenue A Suite B  
Yuma, AZ  
85364

# ROOF INSPECTION SUMMARY – KACHINA MEDICAL PLAZA BUILDING B

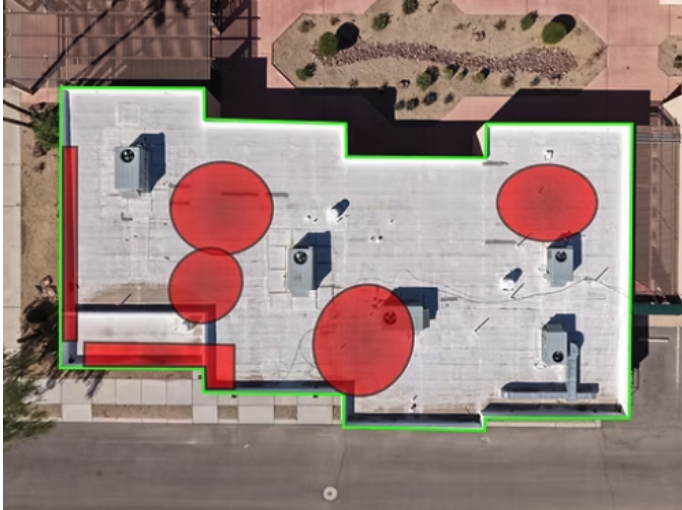
The areas marked in red indicate where we found damage during the interior inspection. We were informed that some ceiling tiles had already been replaced, which limited our ability to identify all leaks from inside the building. After completing the roof inspection, we discovered additional areas with issues and leaks that will be included in our proposal.

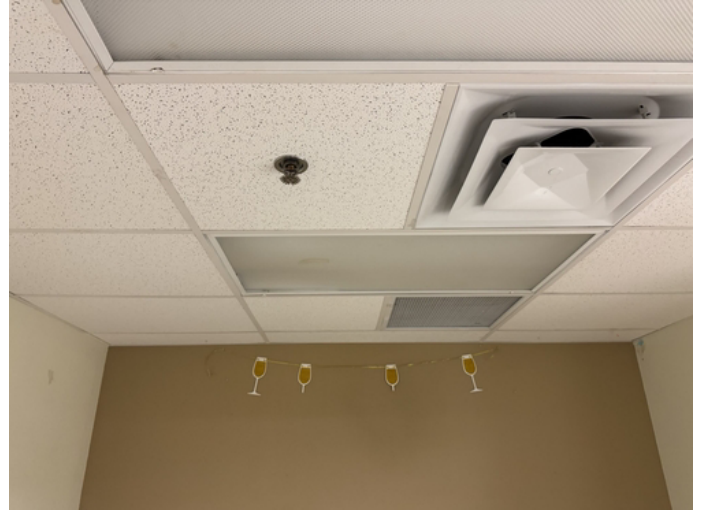
Interior tile with water stains
